Highlands
HOME INSPECTIONS

DEC 8 2022

CLIENT: SCOTT SMITH

HOME FACT SHEET

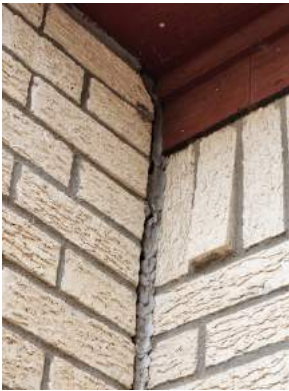
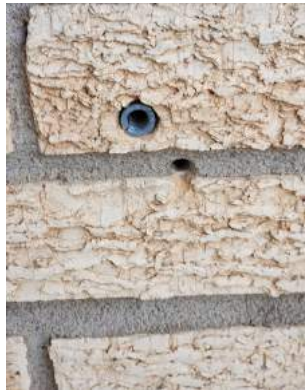
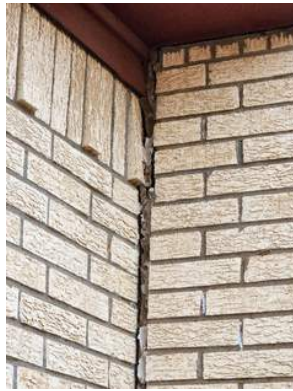
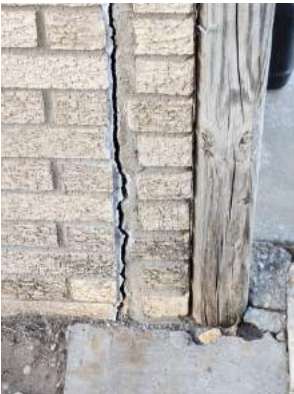
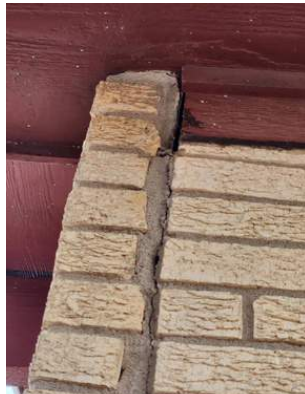
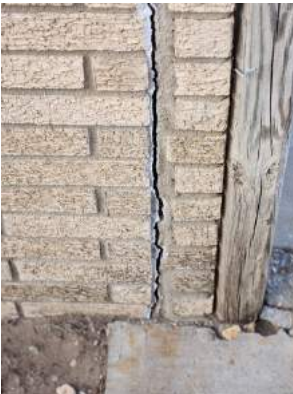
DAMAGED WALL-COVERING MATERIAL

I observed indications of a defect at the exterior wall-covering material. Correction and further evaluation is recommended.

Contact a qualified professional.

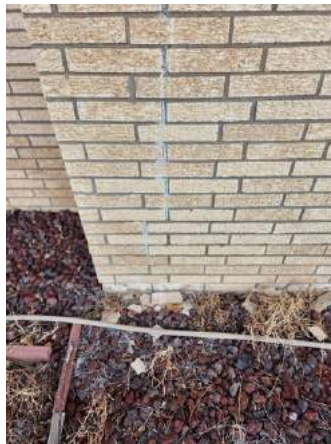
CRACKING - MAJOR AT MASONRY EXTERIOR

I observed indications of major structural cracking at the time of my inspection of the exterior. Cracking was observed at one or more areas. Monitoring the masonry walls of the house is needed. Although masonry can deform elastically over long periods of time to accommodate small amounts of movement, large movements normally cause cracking. Cracking can result from a variety of problems: differential settlement of the foundation; drying shrinkage; expansion and contraction due to ambient thermal and moisture variations; improper support over openings; the effects of freeze-thaw cycles; the corrosion of iron and steel wall reinforcement; differential movement between building materials; expansion of salts; and the bulging or leaning of walls. Further evaluation is recommended.

INSTALL GUTTER SYSTEM

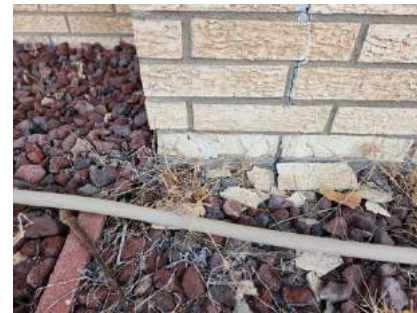
3.4.1 Vegetation, Surface Drainage, Retaining Walls & Grading

Grading is sloping towards the home in some areas. This could lead to water intrusion and foundation issues. The ground around a house should slope away from all sides, ideally 6 inches for the first 10 feet from the house foundation perimeter. Downspouts, surface gutters and drains should also be directing water away from the foundation.

Contact a qualified landscaping contractor

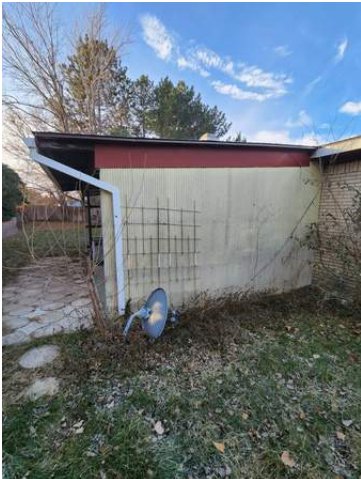
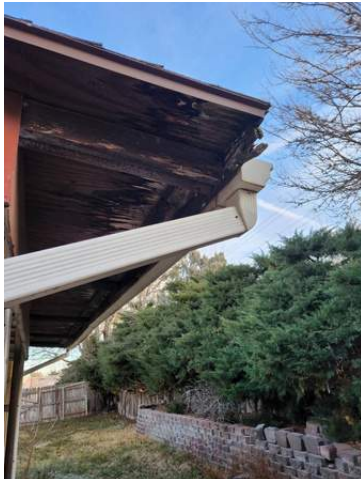
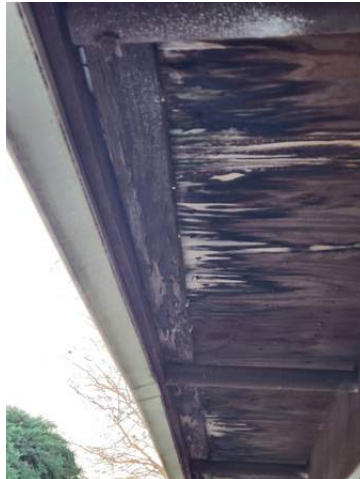
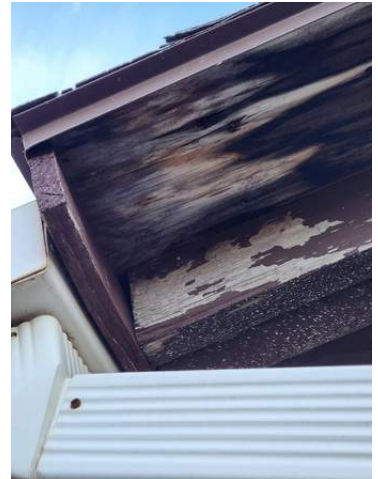
3.8.1 Porches, Patios, Decks, Balconies & Carports **WOOD ROT**

I observed wood rot at the patio awning . This condition is a structural defect. Correction and further evaluation of the patio awning is recommended.

Contact a qualified carpenter.

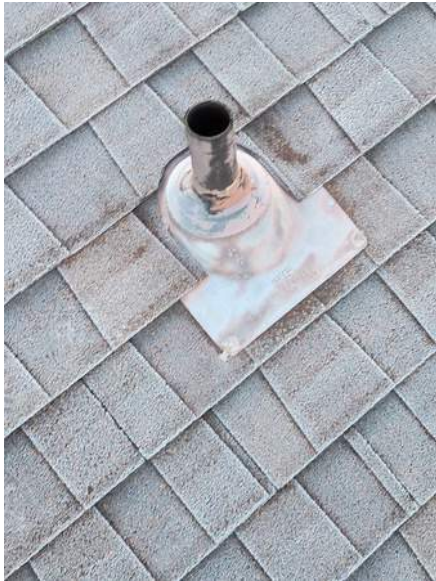
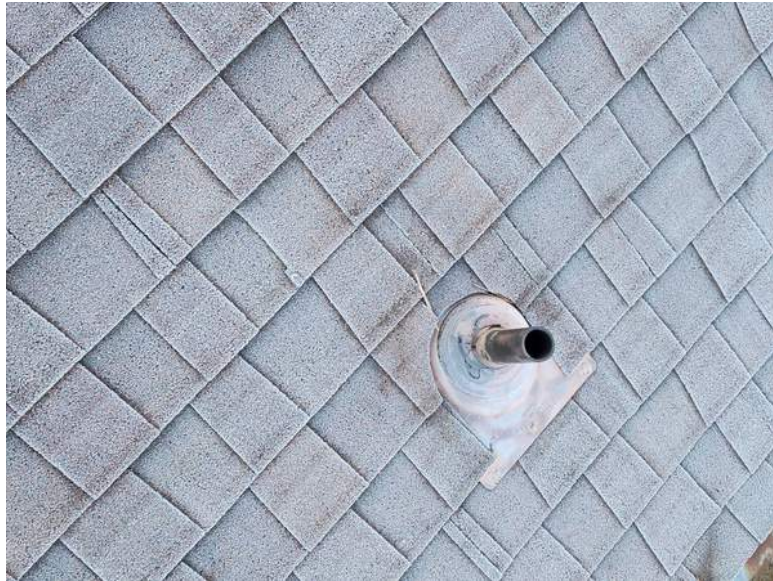
Plumbing Vent Pipes: Plumbing Vent Pipes Inspected

I looked at DWV (drain, waste and vent) pipes that pass through the roof covering. There should be watertight flashing (often black rubber material) installed around the vent pipes. These plumbing vent pipes should extend far enough above the roof surface.

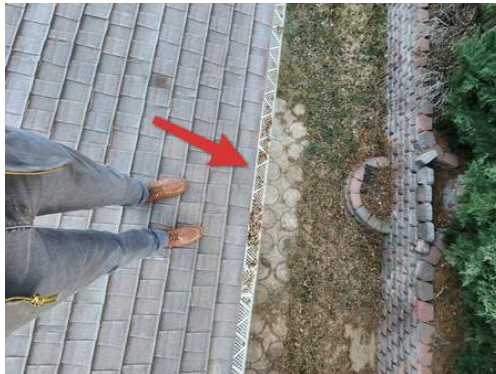
I observed debris in the gutter. Location was on the patio awning.
Cleaning and maintenance is recommended.

Contact a qualified gutter contractor

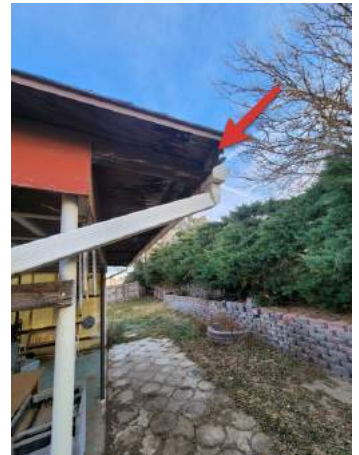
2.4.2 Gutters & Downspouts GUTTERS MISSING

Gutters are necessary to properly collect rain water from the roof, control it, divert it, and discharge that water away from the house and its foundation. A missing gutter is a defect. This is a defect that should be corrected by a professional contractor.

Contact a qualified gutter contractor

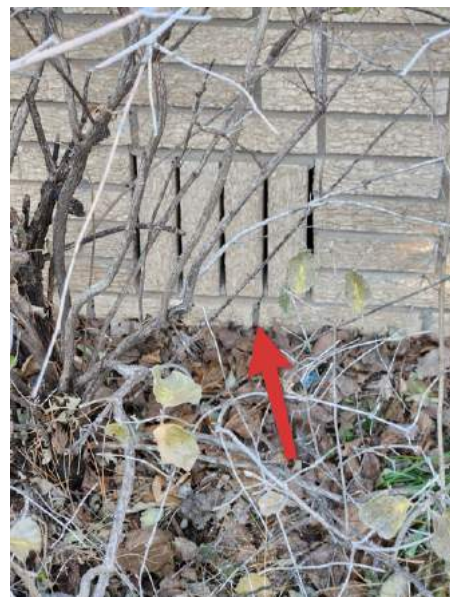
CRAWLSPACE VENTS OBSERVED

The crawlspace is ventilated with the outside. This type of crawlspace and foundation is equipped with permanent vents to the outdoors that are intended to furnish cross-ventilation to prevent moisture in the space. This conventional ventilated crawlspace tend to have inherent problems including energy loss, decreased comfort, excessive moisture, durability issues, and indoor air quality problems. It might be best to implement a closed-crawlspace strategy that treats the crawlspace essentially as a short room with conditioned air. Recommend having a qualified contractor further evaluate the vented crawlspace. Not enough ventilation.

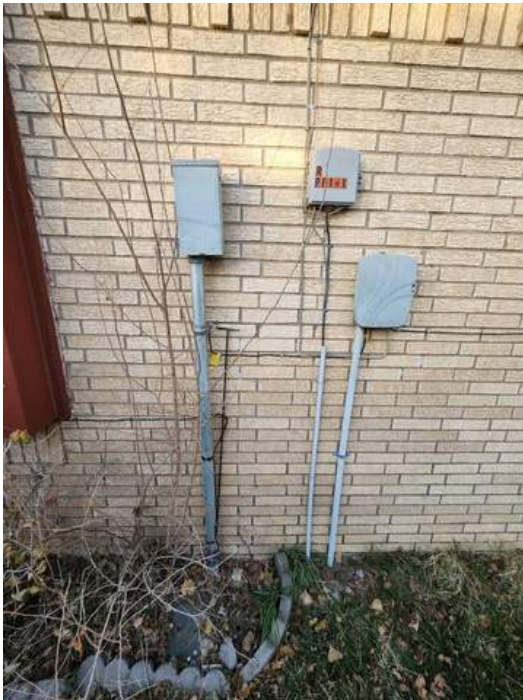
Service-Entrance Conductors: Inspected Service-Entrance Conductors

I inspected the electrical service-entrance conductors.

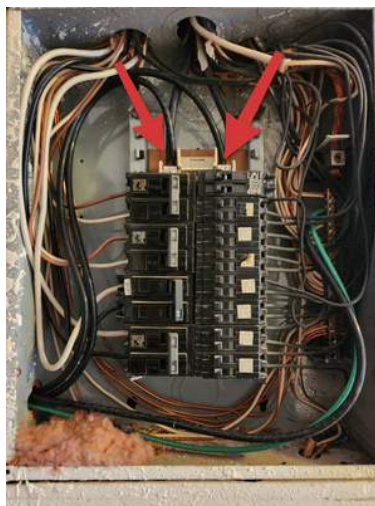
8.5.2 Panelboards & Breakers

MATERIAL DEFECT

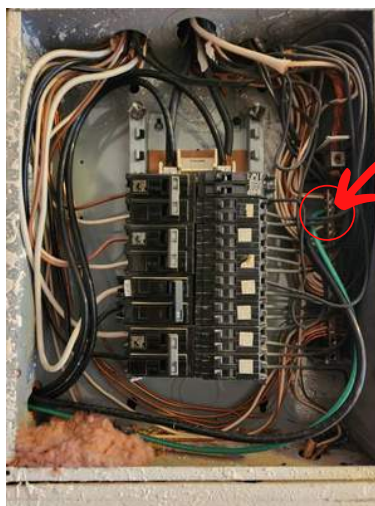
SUBPANEL GROUNDS NEUTRALS NOT SEPARATED

I observed that the grounds and neutrals at the subpanel are not isolated (separated). Defect.

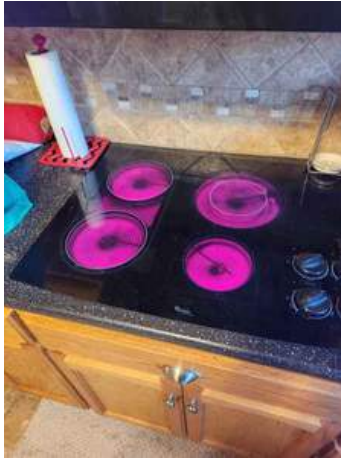
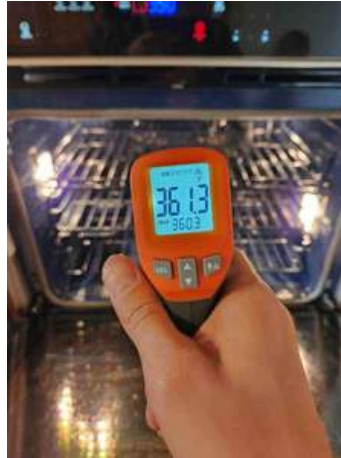
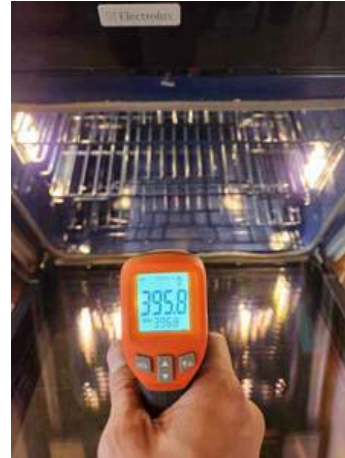
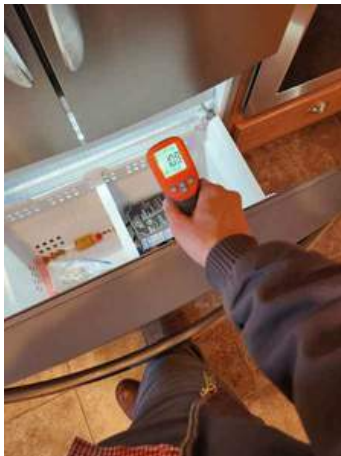
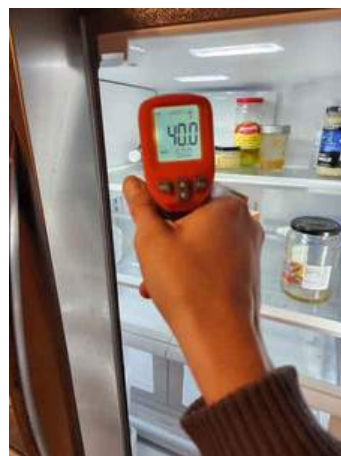
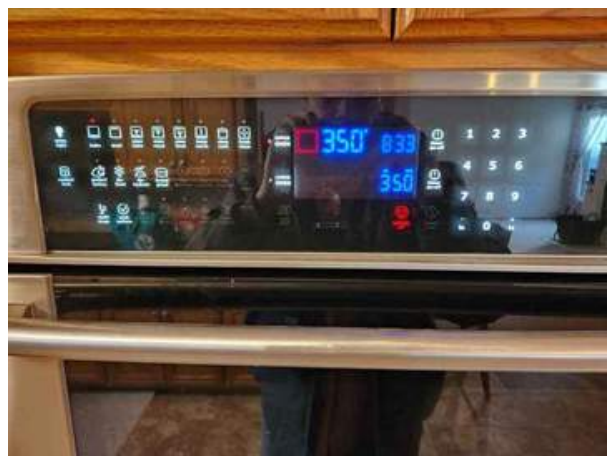
Range/Oven/Cooktop: Turned On Stove & Oven

I turned on the kitchen's stove and oven.
